NATIONAL DAM SAFETY PROGRAM. LEMBECK LAKE DAM (MO 30369), MISSI--ETC(U)

LEMBECK LAKE DAM  
JEFFERSON COUNTY, MISSOURI  
MO. 30369

**PHASE I INSPECTION REPORT  
NATIONAL DAM SAFETY PROGRAM**

PREPARED BY: U. S. ARMY ENGINEER DISTRICT, ST. LOUIS

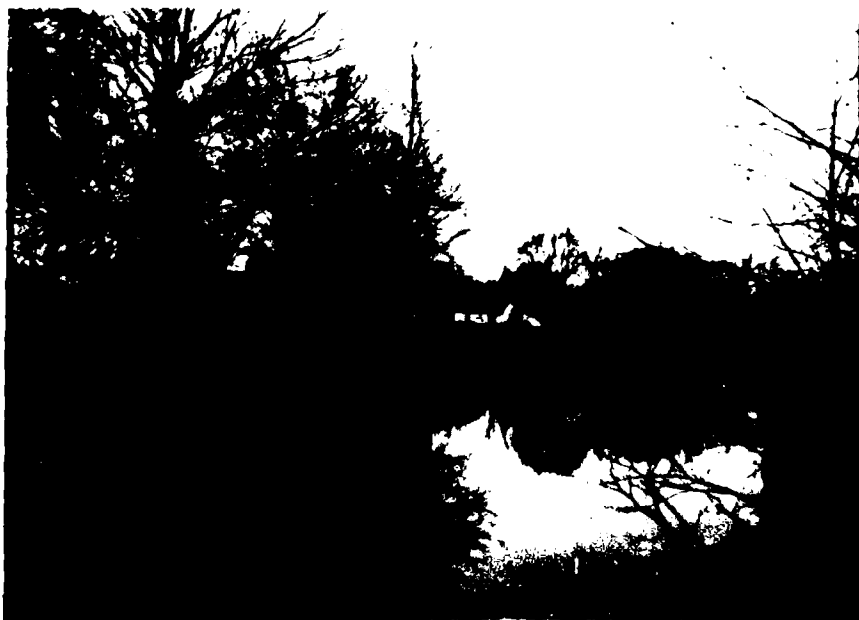
The dam has been classified as having a "high" hazard potential in the National Inventory of Dams, on the basis that in the event of failure of the dam or its appurtenances, excessive damage could occur to downstream property, together with the possibility of the loss of life. From a visual inspection of the downstream area, our findings concur with this classification. Located within the estimated damage zone, which extends less than three miles downstream of the dam, are at least 24 dwellings, four buildings, one railroad embankment, one state highway (Highway 110) and one railroad terminal (see Photo 18).

Photo 18 - View of several dwellings in the downstream hazard zone looking across Joachim Creek.
